# INSPECTION OF CONDENSATE STABILIZER REBOILER

LOCATION	Indonesia	INDUSTRY	Oil and gas
SERVICE PROVIDER	PT. Grahamas Cipta Mulia

DATE OF INSPECTION	23 October 2021
DATE OF REPORT ISSUED	24 October 2021
TOTAL NO. OF TUBES	154
TOTAL NO. OF TUBES INSPECTED	134

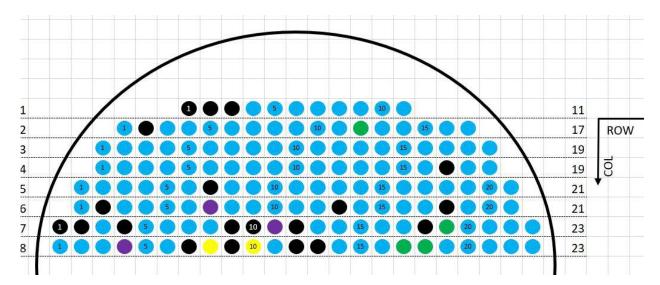
# IRIS REPORTING EXCERPT

NDD			219	71%
11%	-	20%	8	3%
21%	524	40%	27	9%
41%	12	60%	14	5%
61%	-	100%	- (	)

No	Row	Column	Depth Wall loss (%)	Range of Defect	Remaining Wall Tickness (mm)	Sido Eval.	Location (from U- Tube), estimate in mm
1	2	6	10%	-	1.90	OD_CORR	1000mm
2	2	8	9%		1.92	OD_CORR	670mm
3	2	10	10%		1.90	OD_CORR	150mm
4	2	12	13%	-	1.84	OD_CORR	1022mm
5	6	7	33%		1.41	OD_PIT	3360mm
6	7	11	38%	-	1.31	OD_PIT	3825mm
7	7	19	20%	-	1.69	OD_CORR	1650mm
8	7	20	9%	-	1.92	OD_CORR	530mm
9	8	4	27%	\ <del>_</del>	1.54	OD_PIT	3920mm
10	8	8	45%	_	1.16	OD_PIT	4650mm
11	8	10	44%	-	1.18	OD_PIT	4175mm
12	8	17	17%		1.75	OD_PIT	273mm
13	8	18	15%		1.79	OD_CORR	2100mm
14	9	5	44%	2	1.18	OD_CORR	4300mm
15	9	6	39%	_	1.29	OD_CORR	4300mm
16	9	8	48%	-	1.10	OD_CORR	4350mm
17	9	10	50%	-	1.06	OD_PIT	3490mm
18	9	11	49%	-	1.08	OD_PIT	4300mm
19	10	5	40%		1.27	OD_CORR	3720mm
20	10	7	34%	_	1.39	OD_CORR	4100mm
21	10	8	45%	-	1.16	OD_CORR	4140mm
22	10	11	38%	2	1.31	OD_CORR	4220mm
23	10	13	23%		1.62	OD_PIT	4260mm
24	10	14	30%	-	1.48	OD_PIT	4320mm
25	10	16	26%	-	1.56	OD_CORR	4350mm

26	11	4	37%	=	1.33	OD_CORR	4330mm
27	11	5	30%	-	1.48	OD_PIT	4300mm
28	11	6	31%	-	1.46	OD_PIT	4300mm

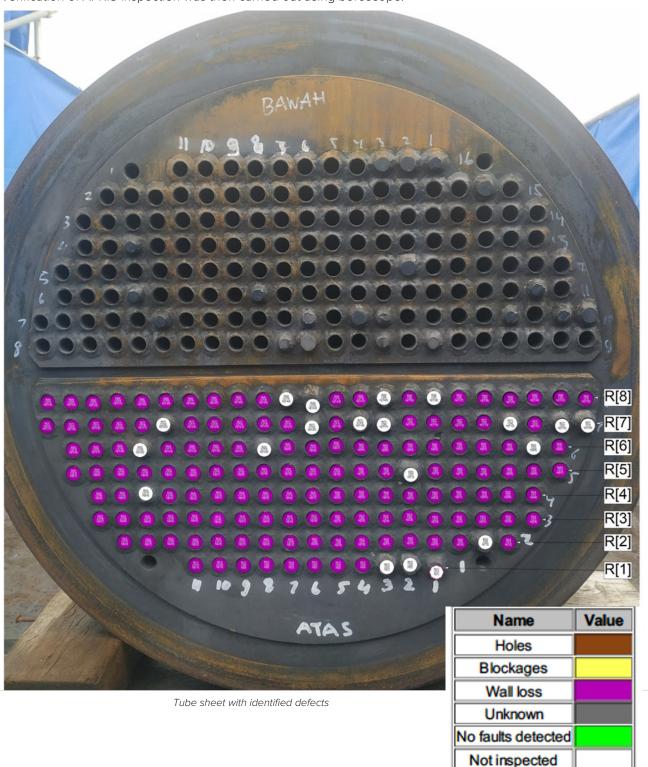
Fault distribution chart

After inspection using APRIS, all 134 tubes were found to have wall loss of 15-30% and its exact location was reported. 17 of these localized wall losses occurred in the bend area of the tube.

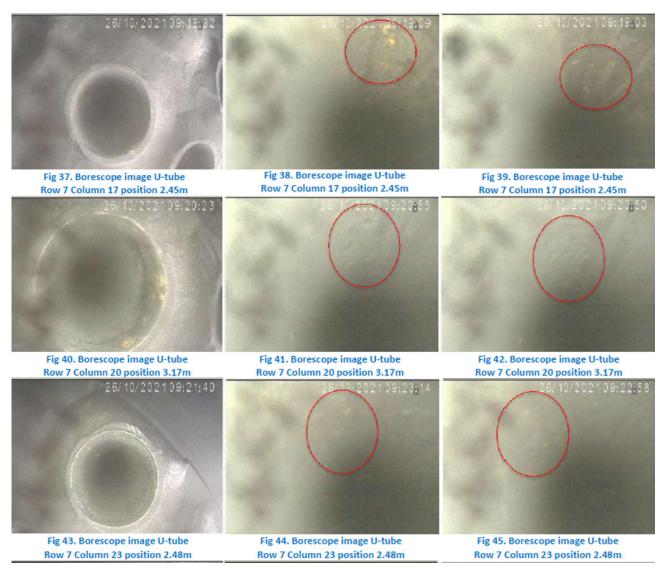
Some photographs taken by boroscope

Visual inspection using boroscope was conducted to confirm the tubes internal condition with maximum wall loss of 35%, as IRIS reported defect free on inner surface of all reboiler tubes.
