## APR INSPECTION ON HEAT EXCHANGER TUBES IN CHINA

| DATE OF INSPECTION | 24 July 2021 | TOTAL NO. OF TUBES INSPECTED | 1,452 |
| LOCATION | Guangzhou, China | CONFIGURATION | Straight tubes |

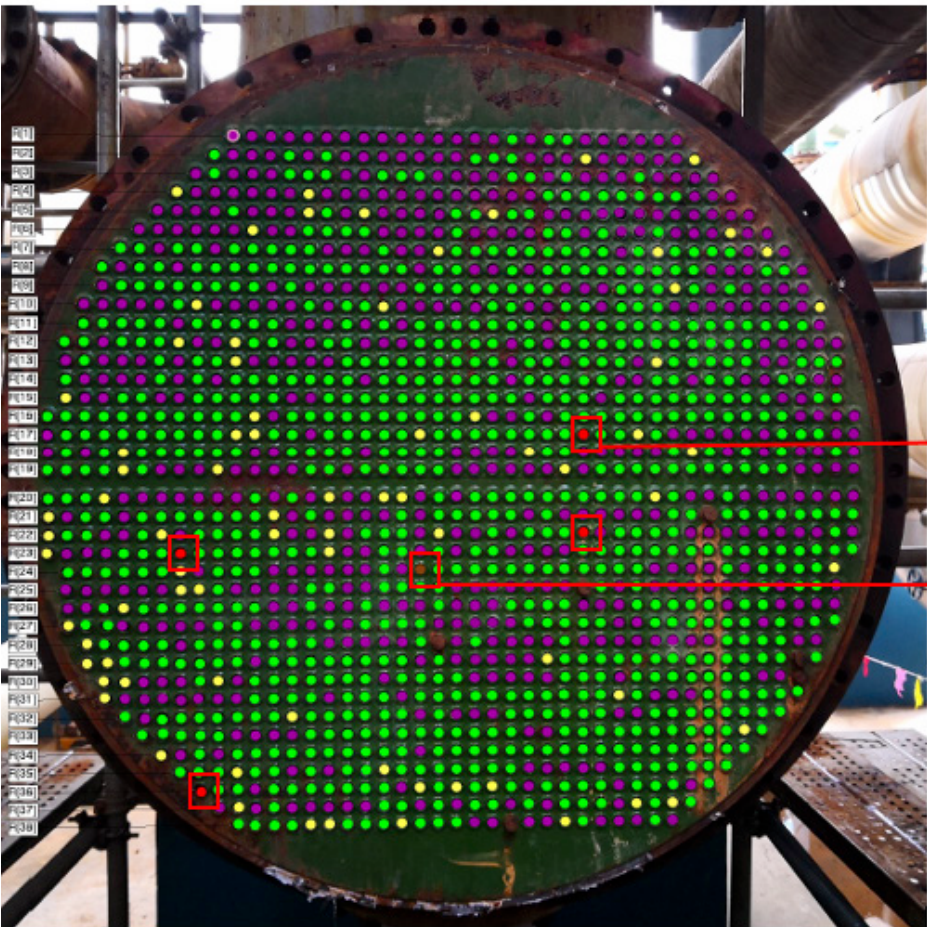
Image 1: Tube sheet defects marking.

After measurements were taken by APRIS, a report was submitted the next day. One (1) tube had been identified with a 1mm hole and four (4) tubes with more than 60% wall loss. There were several tubes with blockages.
