LNG Carrier (Malaysia)

Boiler Tube Inspection

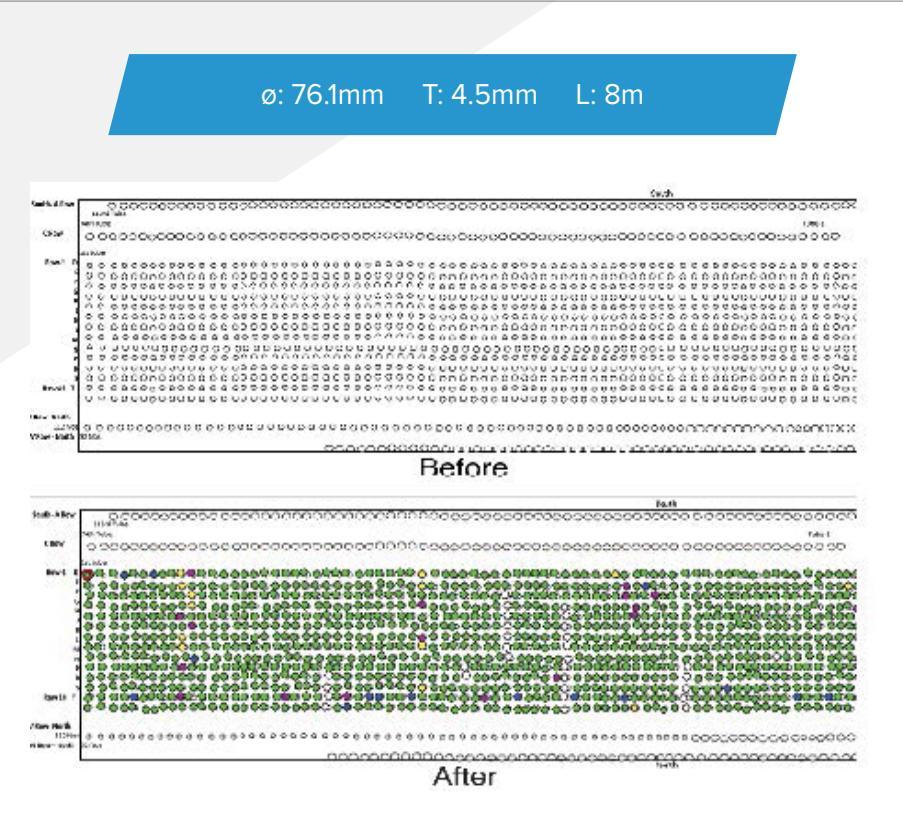
TUBE SHEET DIAGRAM

Based on APR signal analysis, corrosion was detected in 15.9% of the total tubes inspected while 1 tube was found to have a 4mm hole.

Tubes with corrosion > 40% wall loss were plugged while the tube with the hole was replaced.
